# 03/01/94 Northwest Airlines

## Official Accident Report Index Page

NORTHWEST AIRLINES FLIGHT 18 BOEING 747-  
251B, N637US NEW TOKYO INTERNATIONAL  
AIRPORT NARITA, JAPAN MARCH 1, 1994

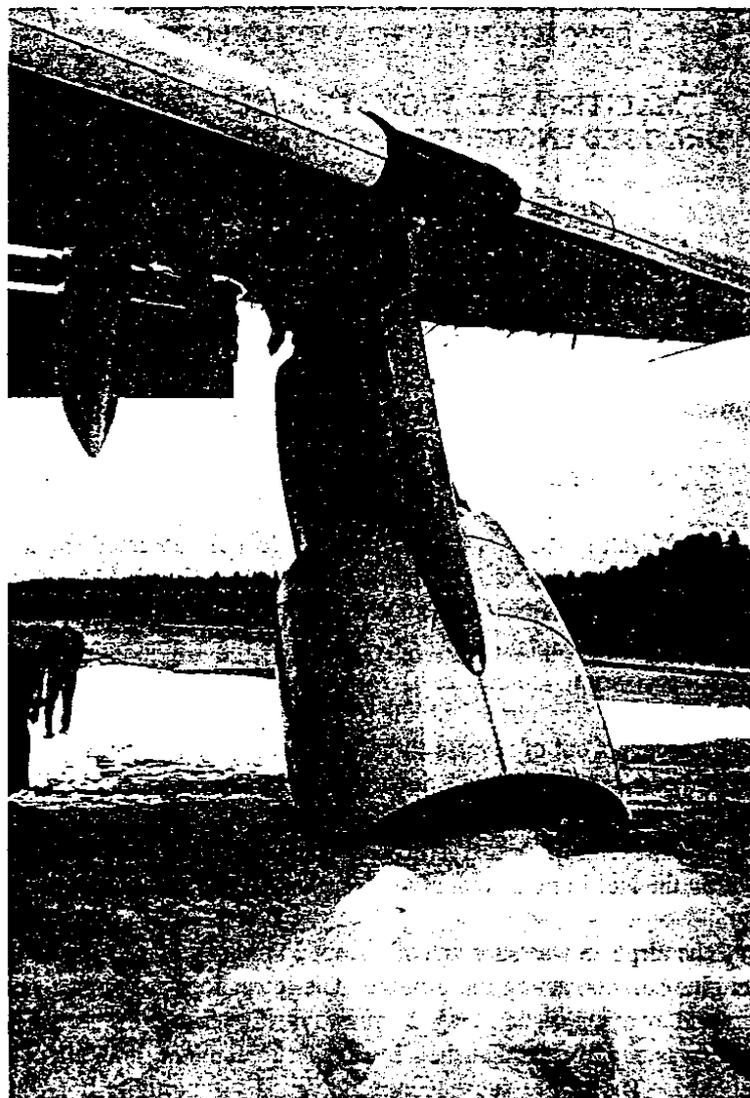
The airplane was subsequently stopped on a taxiway, with the front of the No. 1 engine still contacting the ground. The lower forward engine nose cowl had been ground away as it slid along the runway. (See figure 1). A fire near the No. 1 engine was rapidly extinguished by local fire fighters, and all passengers remained aboard. They were subsequently deplaned via portable boarding stairs about 30 minutes after the airplane was brought to a stop. There were no injuries.

Figure 1.--No. 1 engine.

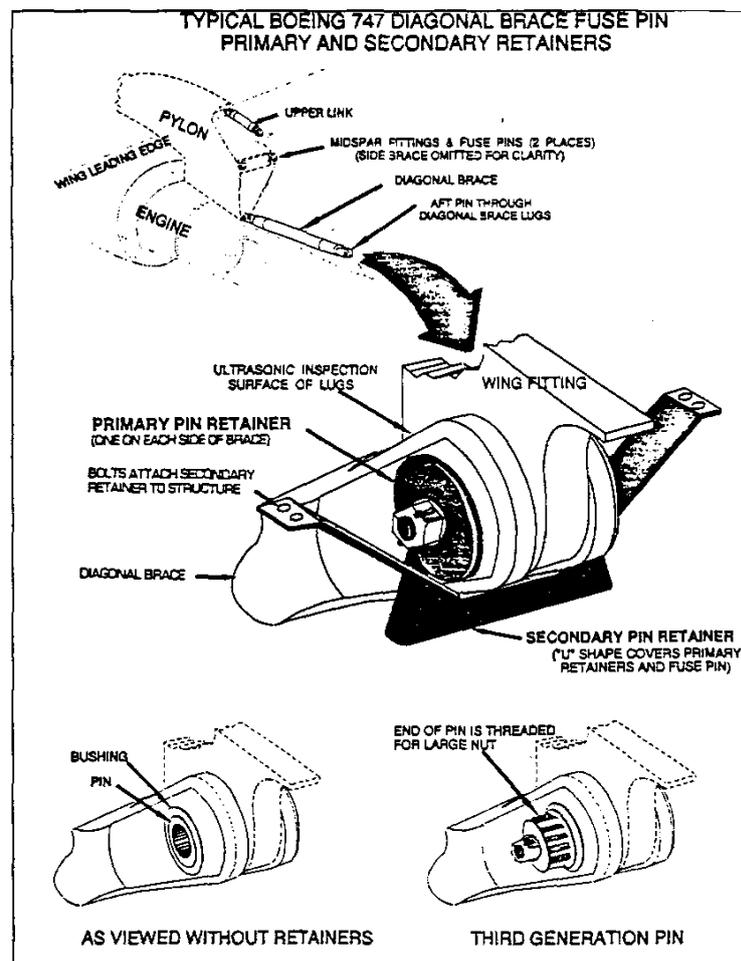
Prior to this landing, at some unknown time, the aft fuse pin on the pylon diagonal brace had migrated out of its fitting. The pin was found loose in the pylon structure. It was intact, undamaged, and had no evidence of preexisting defects. The aft diagonal brace fuse pin is normally retained by both a primary retainer (two washer-like retainer caps and a through bolt) and a secondary retention clip (a bolt-on C-shaped bracket). (See [figure 2](#)). However, a search of the airplane pylon and engine area, as well as the runway surface at Narita, revealed neither the aft diagonal brace fuse pin primary nor secondary retaining devices.

**Figure 2.--Diagonal brace attachment details.**

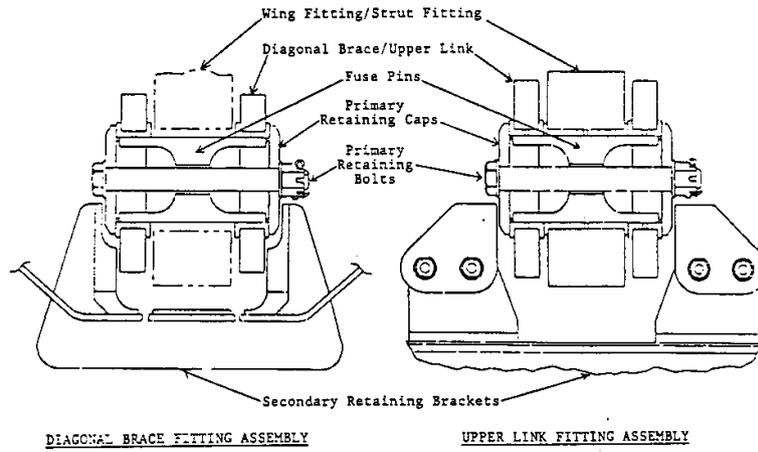
The fractured forward upper link fuse pin from the No. 1 pylon was recovered in three pieces and was retained by the JAAIC for metallurgical examination. Examination of the pin revealed that it fractured in static overload and that there was no evidence of preexisting fatigue.

**Figure 3.--Diagonal brace and upper link fitting assemblies.**
